Fire Growth Analysis of the Fire of
March 20, 1990, Pulaski Building,
20 Massachusetts Avenue, N.W., Washington, DC

Harold E. Nelson

Issued June 1994

Prepared for: U.S. Dept. of Army
Corps of Engineers

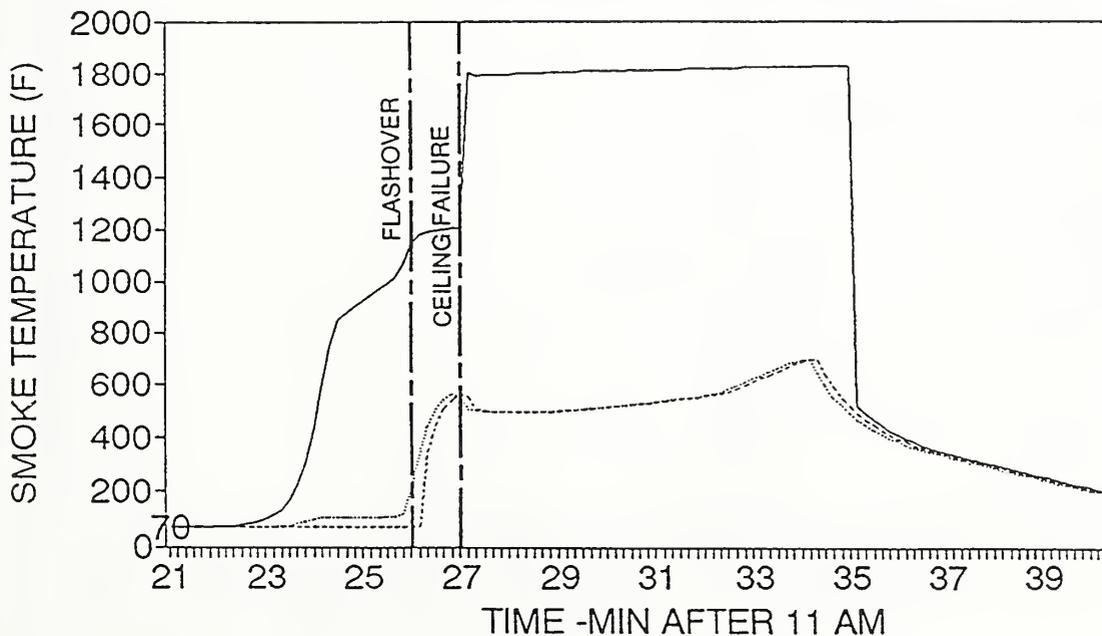
FIGURE 8. SMOKE TEMPERATURE

CONF. RM.
 SUITE
 OTHER AREAS

Figures 8 through 12 provide graphic representation of the estimated change in environmental conditions. These graphs cover rise in temperature, estimated depth of smoke, oxygen in the smoke, carbon monoxide increases in the smoke, and vision distance through the smoke.

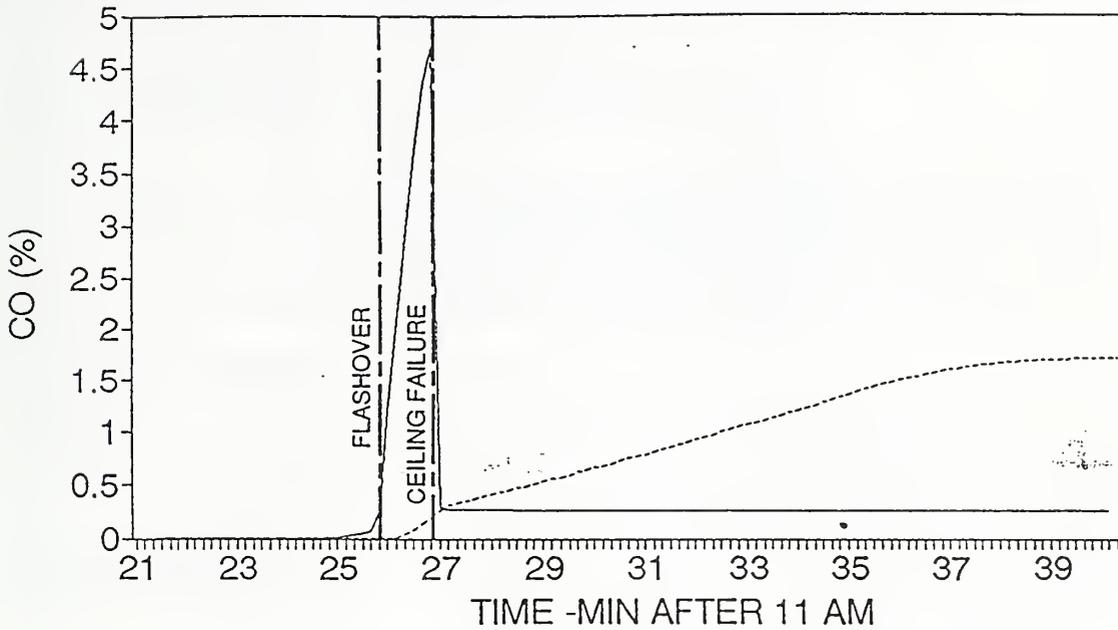
FIGURE 11. CO IN SMOKE

— CONF. RM. OTHER AREAS

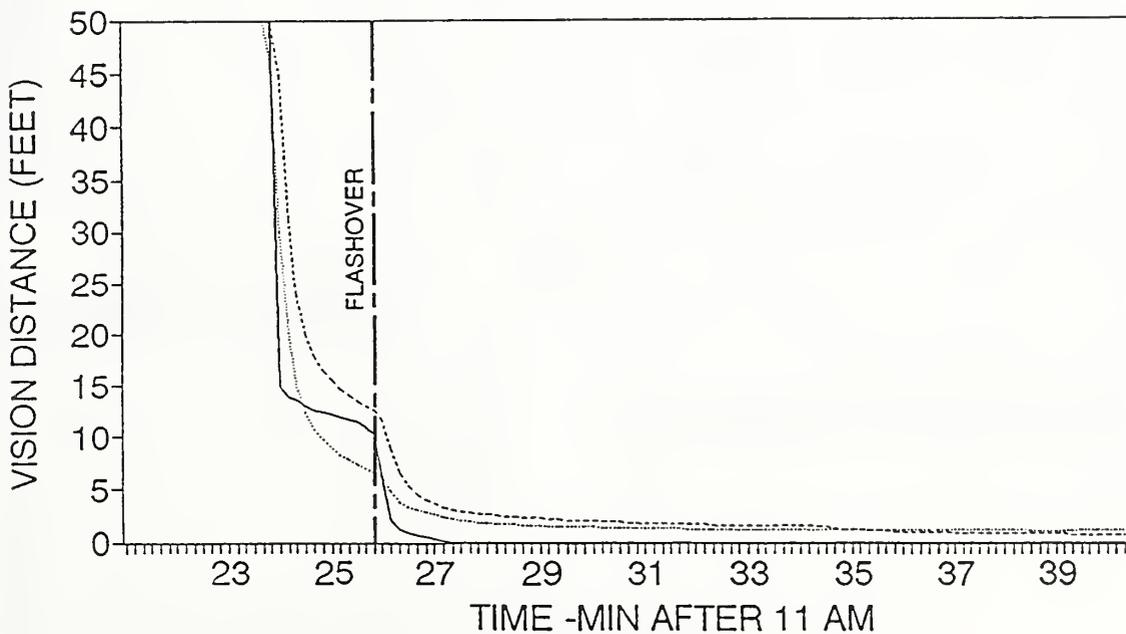
FIGURE 12. EST. VISION IN SMK.

— CONF. RM. - - - SUITE OTHER AREAS

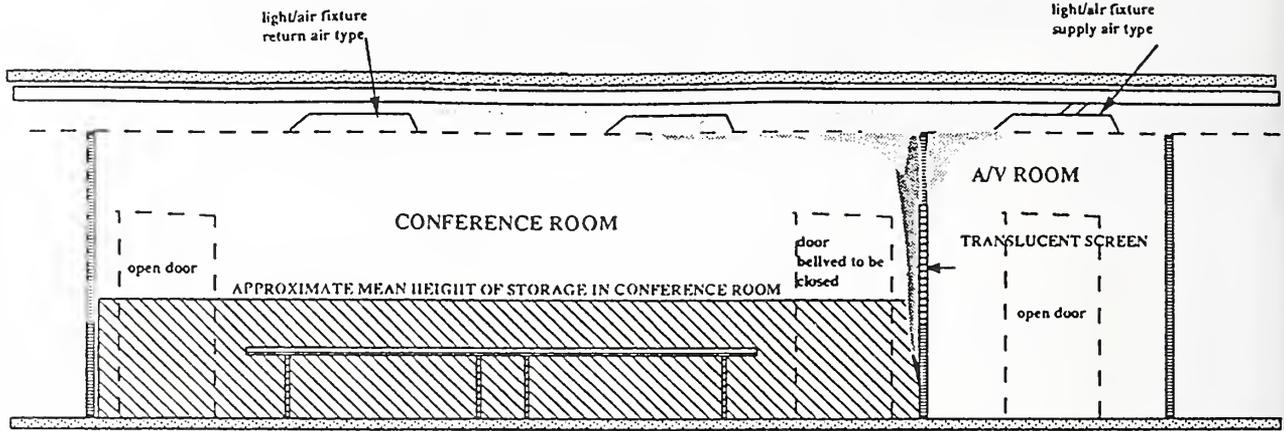
FIGURE 13. ELEVATION - CONFERENCE ROOM AREA - ABOUT 11:22 AM

OPEN FLAMING HAS STARTED PROBABLY DURING THE PRECEDING MINUTE.

FIRE IS ABOUT 10KW. FLAME IS LESS THAN 1-FOOT HIGH/ 11AND FIRE EXTINGUISHER WOULD BE EFFECTIVE.

AIR TRANSFER THROUGH LIGHT FIXTURES - SOME SUPPLY, SOME RETURN (LOCATIONS SHOWN MAY NOT BE ACTUAL LOCATIONS AT TIME OF FIRE.

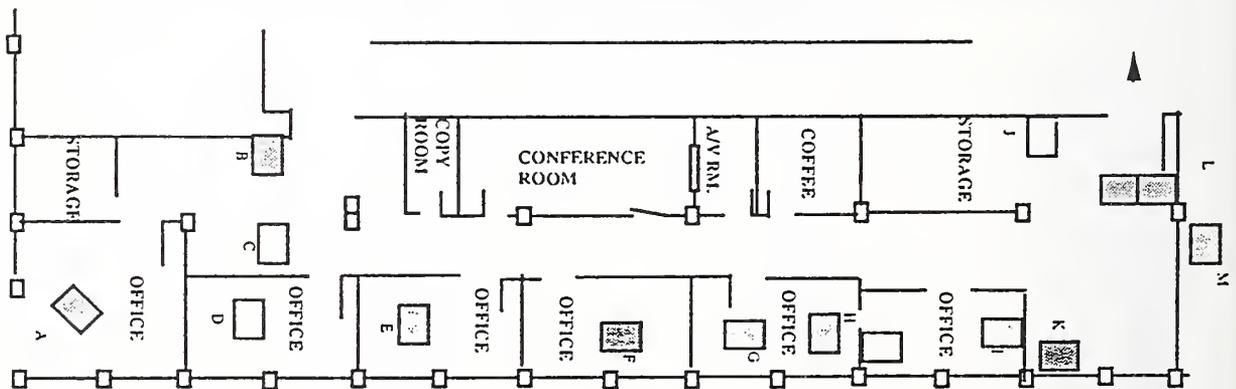
FIGURE 14. ACTIVITIES IN ABMC SUITE - ABOUT 11:15 TO 11:22 AM

- PERSONS F & K LEAVE ABMC -
 - PERSON K HAD BEEN IN A/V ROOM AT ABOUT 10:16 AND PERSON F PASSED EAST (CLOSED) DOOR OF CONFERENCE ROOM AS HE LEFT. NEITHER NOTED ANYTHING UNUSUAL

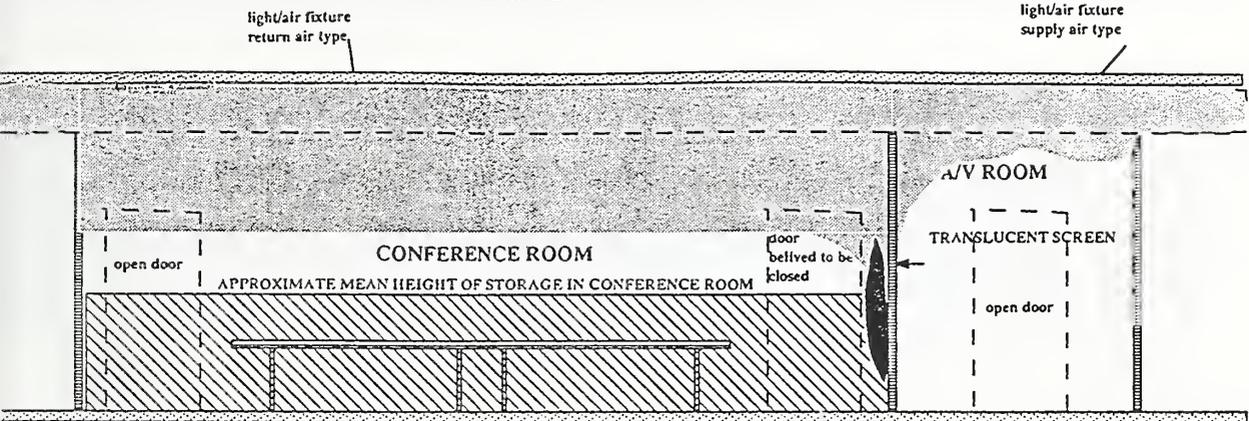
FIGURE 15. ELEVATION - CONFERENCE ROOM AREA - ABOUT 11:23 AM

FIRE IS ABOUT 100 KW (LARGE WASTE BASKET) SIZE. IS CLOSE TO THE MAXIMUM SIZE WHERE HAND FIRE EXTINGUISHER WOULD BE EFFECTIVE.

A NOTICEABLE THIN SMOKE IS ACCUMULATING AT THE CEILING. MORE IS BEING PULLED INTO THE CEILING RETURN AND SEEPING INTO THE A/V ROOM.

FLAME IS ABOUT 5 FEET HIGH.

THIS APPROXIMATELY THE TIME WHEN A QUICK RESPONSE SPRINKLER WOULD HAVE OPERATED (IF PRESENT)

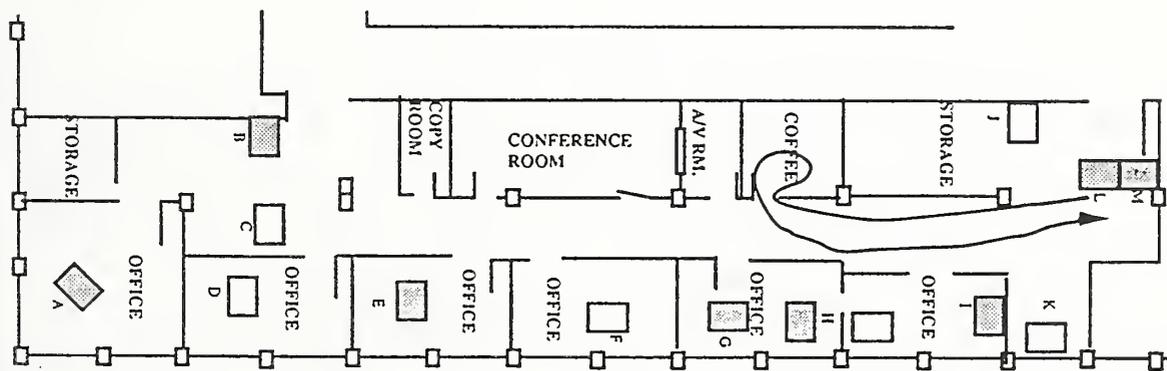
FIGURE 16. ACTIVITIES IN ABMC SUITE - ABOUT 11:22 TO 11:23 AM

PERSON L TRAVELS TO COFFEE ROOM, OBTAINS CUP OF COFFEE AND RETURNS TO HER WORKSTATION. REPORTS NOTHING.

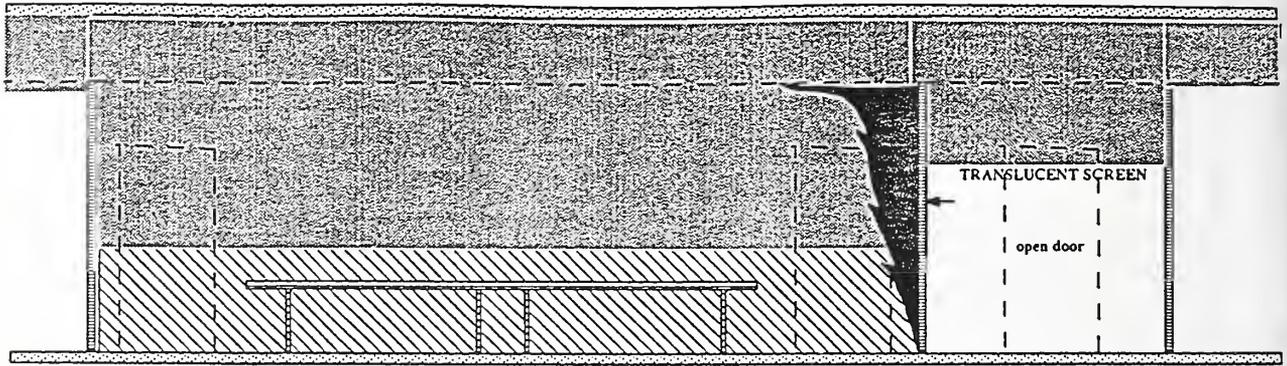
FIGURE 17. ELEVATION - CONFERENCE ROOM AREA - ABOUT 11:24 AM

FIRE IS ABOUT 800KW (AS BIG AS A FULLY INVOLVED UPHOLSTERED EASY CHAIR.) SIZE IS TOO LARGE FOR HAND FIRE EXTINGUISHER ATTACK.

A GRAY SMOKE IS IN THE UPPER HALF OF THE ROOM. THE SMOKE IS CLEARLY EVIDENT BUT DOES NOT YET BLOCK OUT A SIGNIFICANT QUANTITY OF LIGHT FROM THE CEILING FIXTURES. THE SMOKE IN THE A/V ROOM HAS DESCENDED BELOW THE TOP OF THE DOOR OPENING. SMOKE IS BEGINNING TO BE RECIRCULATED BY THE BUILDING FANS.

FLAME EXTENTION IS NOW IN THE RANGE OF 9 -11 FEET AND STARTING TO BEND ACROSS THE CEILING.

A STANDARD SPRINKLER HEAD WOULD HAVE OPERATED ABOUT 30 SECONDS PRIOR TO THIS TIME (IF PRESENT)

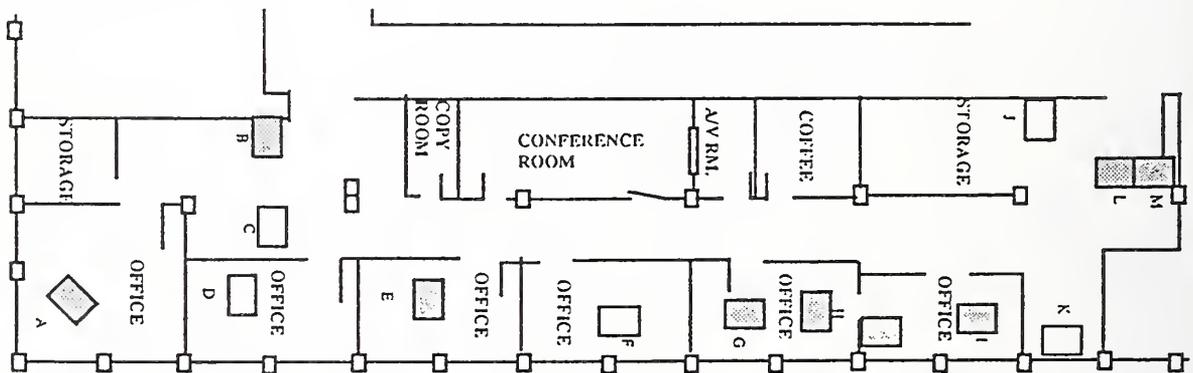
FIGURE 18. ACTIVITIES IN ABMC SUITE - ABOUT 11:23 TO 11:24 AM

NO ACTIVITY RELATED TO THE FIRE IS KNOWN TO HAVE OCCURED IN THIS TIME PERIOD.

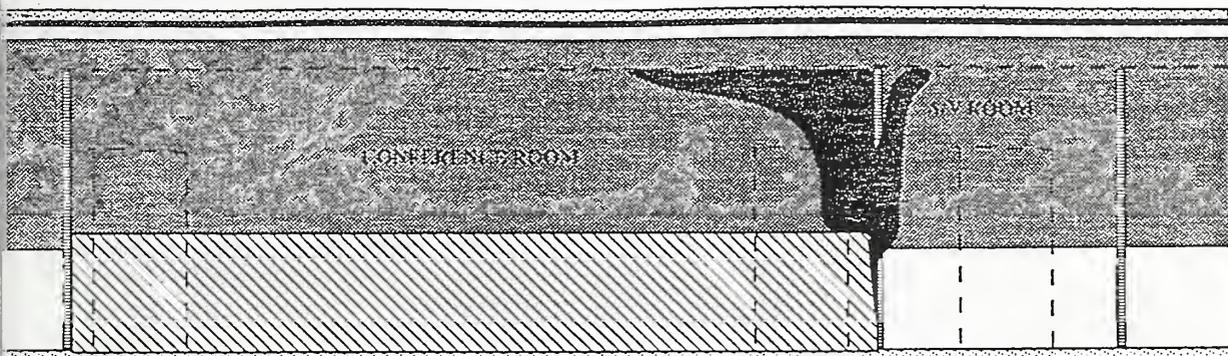
FIGURE 19. ELEVATION - CONFERENCE ROOM AREA - ABOUT 11:25 AM

FIRE SIZE HAS INCREASED TO ABOUT 2 MW. FLAMES ARE LAPPING ACROSS CEILING PROBABLY ALONG THE JUNCTION OF THE CEILING WITH THE SOUTH AND EAST WALLS.

OXYGEN IN THE SMOKE IS DOWN TO ABOUT 10% AND COMBUSTION EFFICIENCY DROPS. THIS RESULTS IN SHARP BLACKENING OF THE SMOKE AND A RISE IN THE CARBON MONOXIDED CONTENT.

THERE IS NO POSSIBILITY OF ENTERING THE ROOM AND LARGE QUANTITIES OF INTOLERABLE GASES ARE SPILLING OUT THE DOOR INTO THE ABMC SUITE

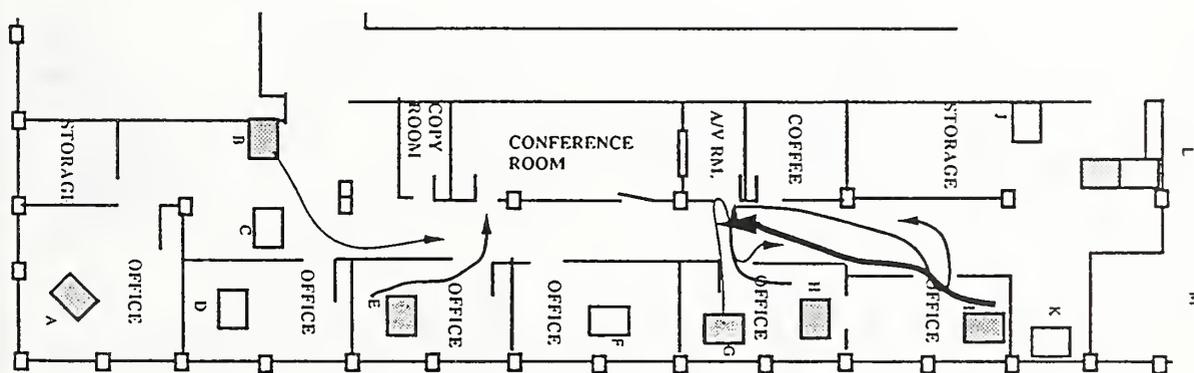
FIGURE 20. ACTIVITIES IN ABMC SUITE - ABOUT 11:24 TO 11:25 AM

- PERSON G SMELLS SMOKE & NOTES HAZE. RISES FROM DESK, STEPS INTO HALL AND SEES SMOKE IN A/V RM. CALLS OUT "SMOKE". RETURNS TO OFFICE TO ALERT OTHERS.. SEARCHES FOR FIRE EXTINGUISHER.

- PERSON H HEARS PERSON G, LEAVES DESK, LOOKS INTO A/V ROOM SEES SMOKE AND GLOW, FEELS HEAT. RETURNED TO OFFICE, TOLD SUPERVISOR (PERSON I) AND STARTED BACK TOWARDS A/V ROOM.

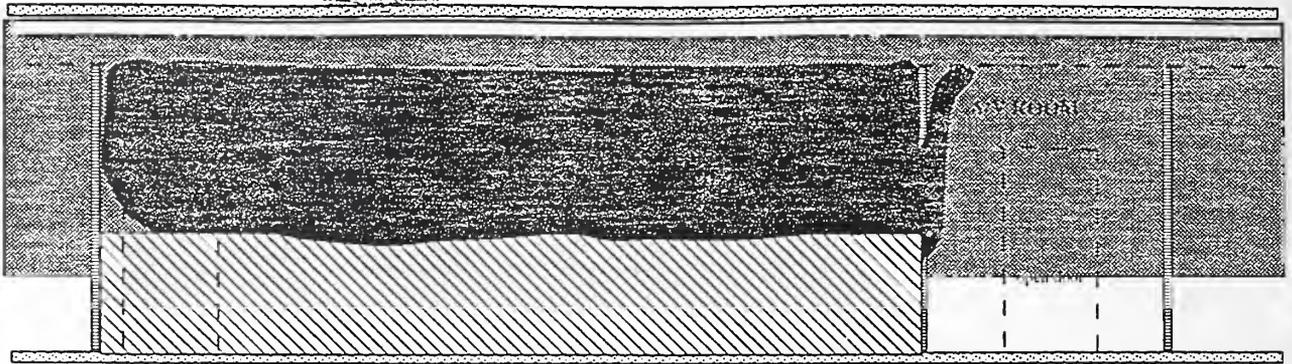
FIGURE 21 ELEVATION - CONFERENCE ROOM AREA - ABOUT 11:26 AM

FLASHOVER OCCURS - THE EXPOSED SURFACES OF ALL COMBUSTIBLE MATERIALS ATTEMPT TO IGNITE. THE ACTUAL BURNING IN THE ROOM IS LIMITED BY THE RATE THAT AIR CAN BE DRAWN INTO THE ROOM. UNBURNED FUEL GAS VENT AS FLAME INTO THE ABMC CORRIDOR.

THE TEMPERATURE IN THE CONFERENCE ROOM QUICKLY RISES TO THE RANGE OF 1200 DEGREES F. THE VIEW INTO THE DOOR IS A MIXTURE OF FLAME AND THICK BLACK SMOKE. OXYGEN IN THE SMOKE IN THE CONFERENCE ROOM DROPS TO NEAR ZERO. THE CARBON MONOXIDE CONCENTRATION IN THE SMOKE RISES TO 3 TO 4%.

THE SMOKE FLOWS INTO THE ABMC SUITE DISTRIBUTING BLACK SOOT AND INTOLERABLE GAS CONCENTRATIONS. TEMPERATURE RISE IN THE SUITE (EXCEPT THAT DIRECTLY RADIATED BY THE FLAME FROM THE CONFERENCE ROOM) RISES ENOUGH TO BE INTOLERABLE TO HUMANS BUT IS WELL BELOW THAT REQUIRED TO IGNITE THE FURNITURE AND OTHER MATERIALS IN THE SUITE.

As is characteristic of fires involving boxes of corrugated paper board construction, the fire developed at a very rapid rate. By about 11:26 a.m., the fire in the Conference Room flashed over². With this occurrence, large quantities of hot black smoke flowed into the rest of the suite. It is likely that the initial post flashover flow of smoke contained potentially lethal concentrations of carbon monoxide. Very soon after flashover, however, the suspended ceiling in the Conference Room started to fail, as this ceiling opened up, the smoke and heat vented into the open plenum space above the ceiling. This changed the nature of the fire from one confined to the suite to one spreading high temperature

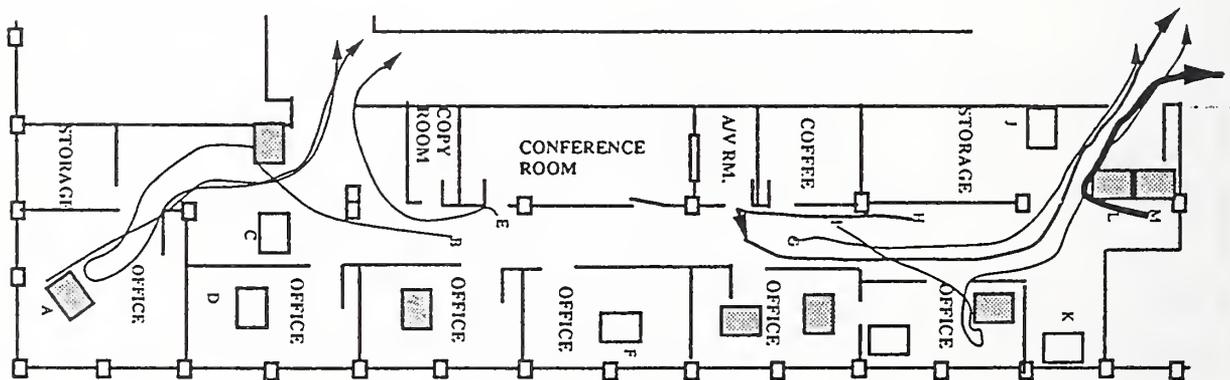
FIGURE 22. ACTIVITIES IN ABMC SUITE - ABOUT 11:25 TO 11:27 AM

- PERSON G EXITS SUITE THROUGH EAST DOOR.
- PERSON H RETURNS TO A/V ROOM FOR SECOND LOOK SEES SMOKE COMING OUT OF A/V ROOM DOOR. LEVEL OF SMOKE IN A/V ROOM DOORWAY AT ABOUT CHEST LEVEL. THEN EXITS SUITE THROUGH EAST DOOR.

- PERSON I GOES TO DESK, GETS PURSE, EXITS SUITE THROUGH EAST DOOR.
- PERSON L SEEN LOOKING DOWN SUITE HALLWAY, THEN TURNS, JOINS PERSON M, LEAVES SUITE THROUGH EAST DOOR AND ATTEMPTS TO OPERATE FIRE ALARM BOX SLIGHTLY EAST OF EAST DOOR.

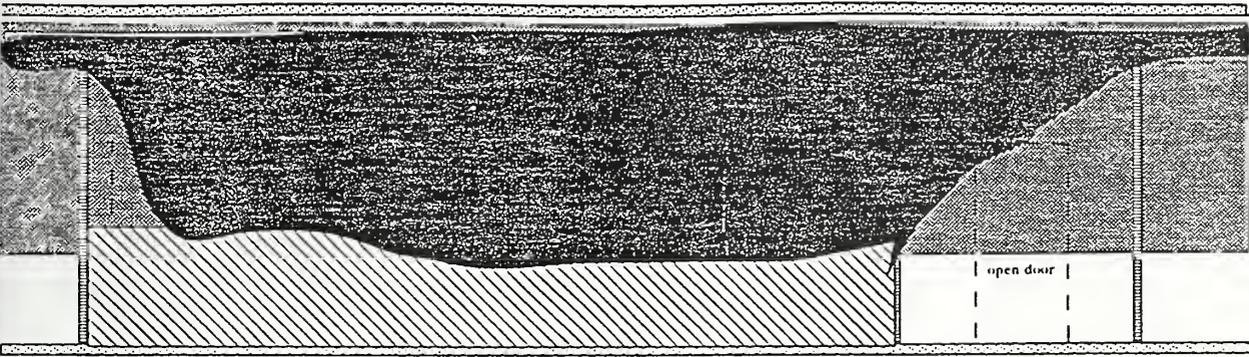
FIGURE 23. ELEVATION - CONFERENCE ROOM AREA - ABOUT 11:27 AM

CEILING FAILS (PROBABLY IN SECTIONS). FLAME IS VENTED INTO CEILING PLENUM SPACE. SMOKE ROUTE CHANGES. LITTLE, IF ANY, MORE SMOKE FLOWS THROUGH CONFERENCE ROOM DOOR INTO ABMC SPACE. DESTRUCTION CONTINUES IN THE CONFERENCE ROOM AND ADJACENT SPACES AND THE ENTIRE FLOOR RAPIDLY FILLS WITH SMOKE GENERATED BY THE FIRE. SMOKE FLOWED INTO THE PLENUM SPACE AND DESCENDING INTO THE GENERAL FLOOR SPACE THROUGH THE CEILING LIGHTING FIXTURES AND OTHER CEILING OPENINGS. BY ABOUT 11:35 AM ENTIRE FLOOR IS FILLED WITH SMOKE TO A LEVEL 1 TO 2 FEET ABOVE THE FLOOR.

The ceiling failure slowed the deterioration of conditions in the ABMC suite, possibly avoiding serious harm to the last person(s) to leave the suite. The failure of the ceiling exposed the wiring of the fire alarm system to direct flame impact, causing it to fail. The fire alarm system failed just moments after a fire alarm box had been pulled by evacuees from the ABMC and adjacent suites. Soon thereafter, portions of the building lighting circuit also failed. The flame entered the plenum space, thus limiting actual burning to the contents of the Conference Room and adjacent spaces. As the flame and other fire effects vented into the plenum, the lighting fixtures and other utilities in the plenum were subjected to flame (nearest the fire source) and hot gases.

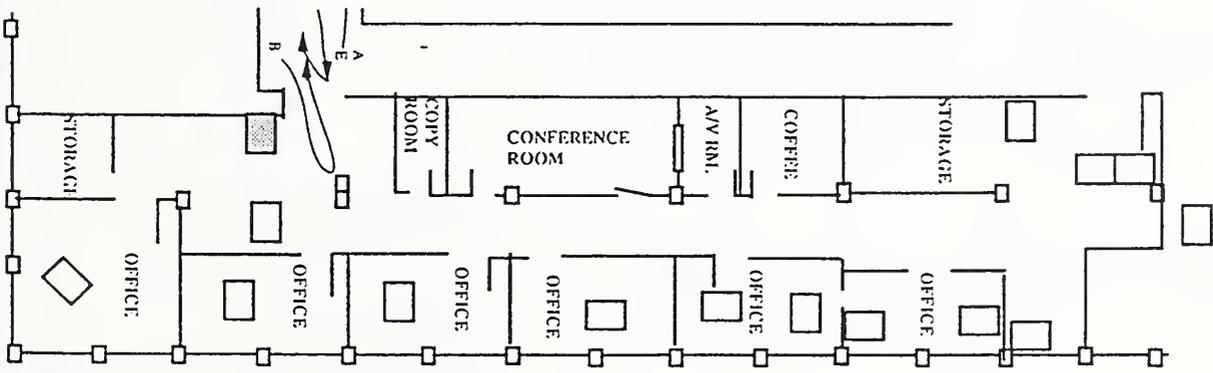
- PERSON E ESCORTS PERSON A INTO STAIRWELL, THEN RETURNS TO WEST ENTRANCE OF ABMC SUITE ,CALLS IN TO ASSURE THAT ALL OCCUPANTS ARE OUT. FINDS B HAS RE-ENTERED SUITE.
- PERSON B RE-ENTERS SUITE, GETS PURSES FROM CLOSET AND LEAVES. SMOKE IS BLACK, AND IRRITATING. PERSON B ESTIMATES THAT SMOKE LEVEL IS BELOW HER WAIST.
- PERSONS B & E THEN LEAVE FLOOR.
- ALL PERSONS THAT HAVE EXITED FROM THE EAST DOOR TO THE SUITE ALSO HAVE EXITED FLOOR ALONG WITH THE OTHER OCCUPANTS OF THE FLOOR.
